# Snake Creek Restoration Project

This project involved the large scale restoration of Snake Creek, a tributary of the Selwyn/ Waikirikiri. Over 3km of stream was transformed by bank repair, native planting and the installation of in stream features and sediment traps.

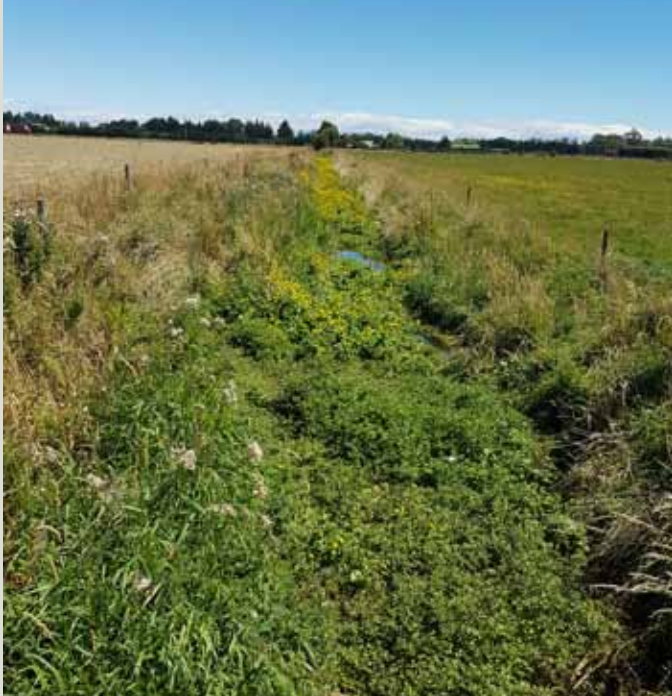
**Monkey musk & watercress completely covering Snake Creek in 2017**

At the beginning of the project (2017) there was little in the way of riparian vegetation.

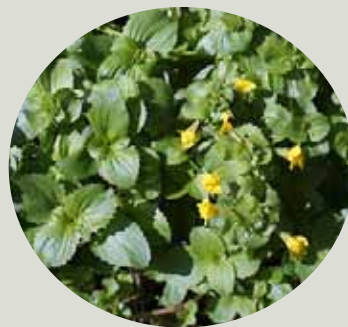
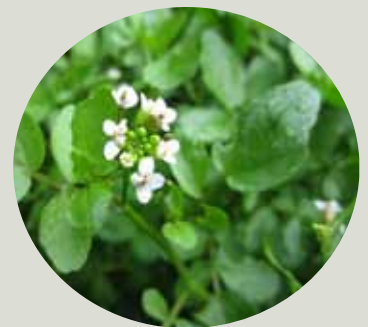
The lack of shade had led to excessive macrophyte growth dominated by introduced monkey musk/ *Erythranthe moschata* (below left) and watercress/ *Nasturtium officinale* (below right). These macrophytes trap sediment, adding to the build up in the stream.

Monkey musk and watercress root from the bank and spread out over the water column. This leads to raised water levels which can lead to water backing up on farm paddocks, and, if the weeds are dislodged in a high rainfall event, can lead to culvert blow outs and other property damage. For this reason they are regularly cleared mechanically and some areas are sprayed with herbicide.

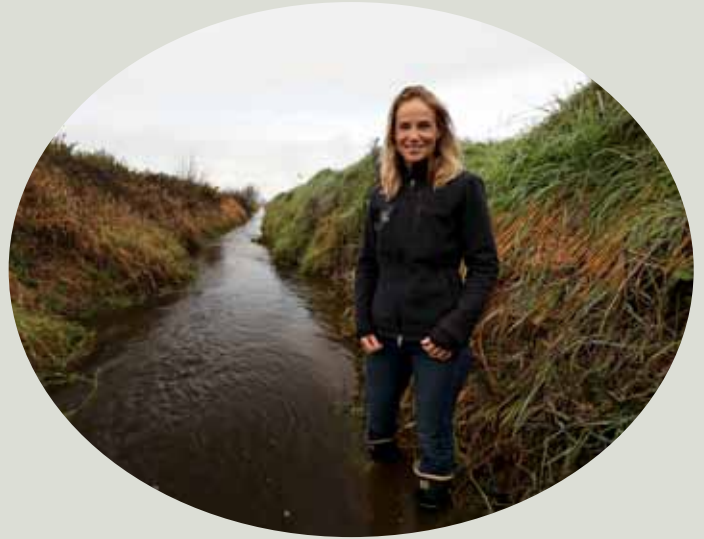
Continued drain clearing had led to overwidened channels that have steep sided banks in many areas. These steep sided areas are prone to erosion.

Mechanical drain clearance has improved in recent years with attempts made to minimise damage by operators, however the stream profile that has been created over the years remains in place and damage does still occur depending on the operator.

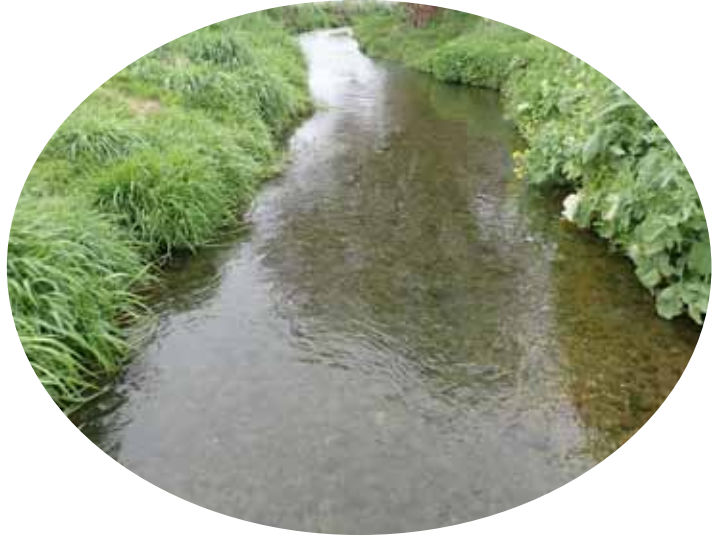
Continued weed clearance had resulted in little build up of leaf litter and woody debris. The surface of the streambed was instead fairly homogenous. Either predominately cobbles and gravel (in higher gradient sections) or cobbles and gravel covered in fine silt (in lower gradient sections).

In some areas there is a fine covering of silt and in other areas it has deposits of up to 20cm deep. It does not take too much of a drop in gradient for this sediment to drop out and accumulate.

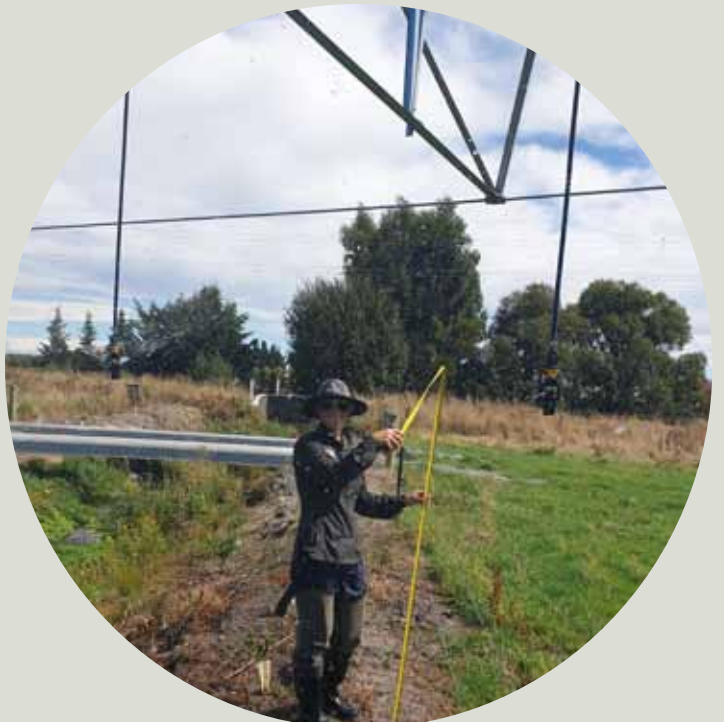
The irrigator nozzles dangle to 1.8m from the ground. This affected the species of riparian plants that were able to be planted, restricting it to low growing shrubs and grasses.

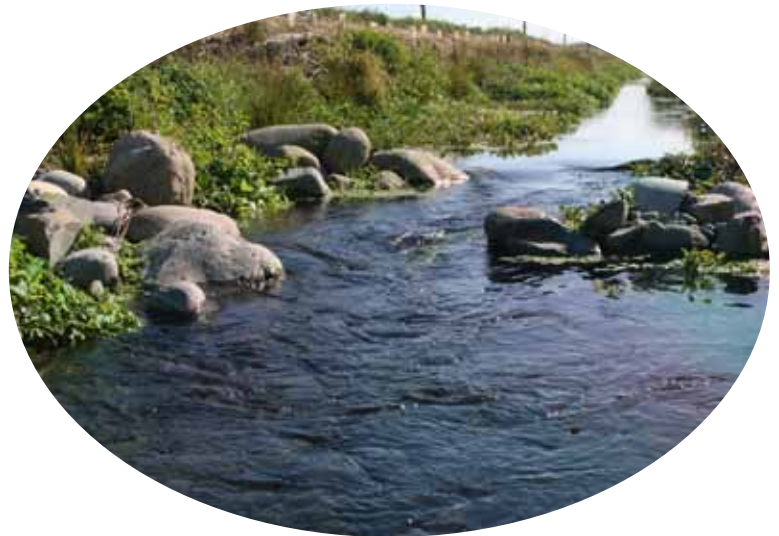
These features created riffles and small pools. Pockets of clean gravel were created where fast flowing water flushed the sediment from the substrate. In addition some areas have led to a build up of sediment.

To create more diversity in the habitat in stream features were placed approximately every 50m over the restored reach. This involved adding boulders to create pinch points and mid and side-stream eddies. Wooden V weirs were also trialed.

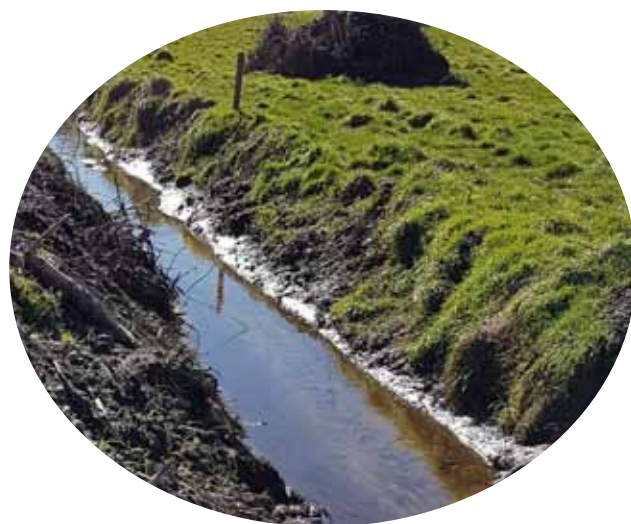
It is hard to know exactly how this sediment is coming in, but it is likely to be from overland flow during significant rain events. Smaller side drains may also be a significant contributor to mainstem sediment loads. These small side drains have the greatest interface with paddocks. No interventions were carried out on side drains, although it is worth noting that the majority of these side drains were fenced prior to the project commencing.

A side drain (small tributary) of Snake Creek.
