# Snake Creek Restoration Project

This project involved the large scale restoration of Snake Creek, a tributary of the Selwyn/ Waikirikiri. Over 3km of stream was transformed by bank repair, native planting and the installation of in stream features and sediment traps.

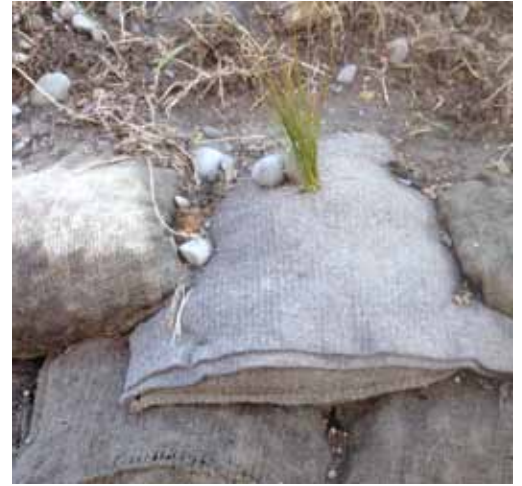
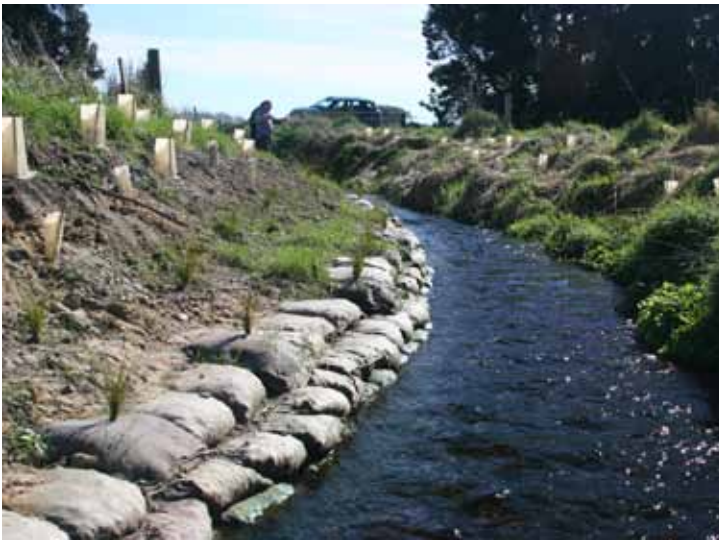
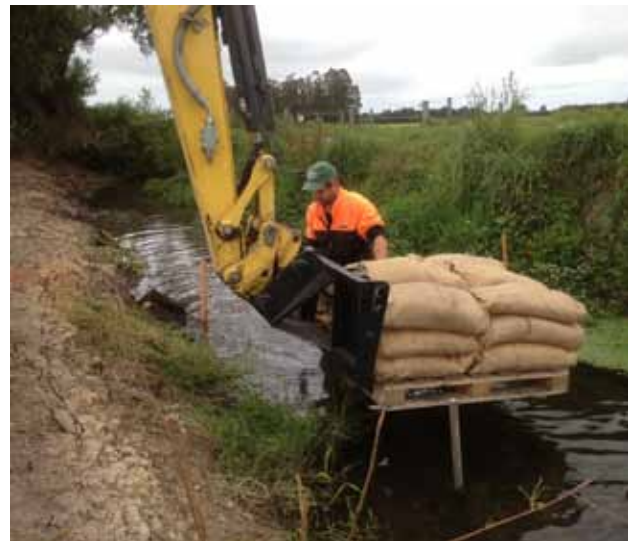
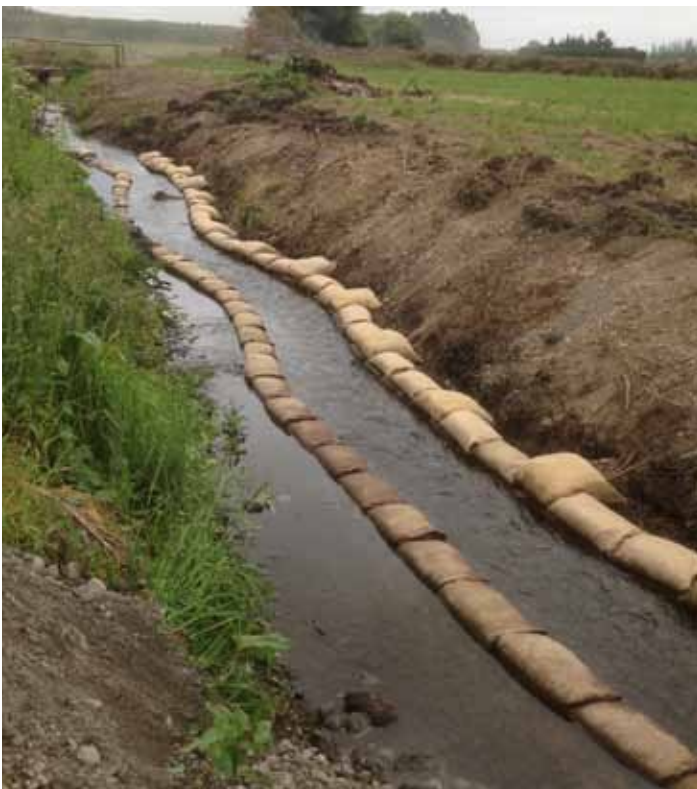
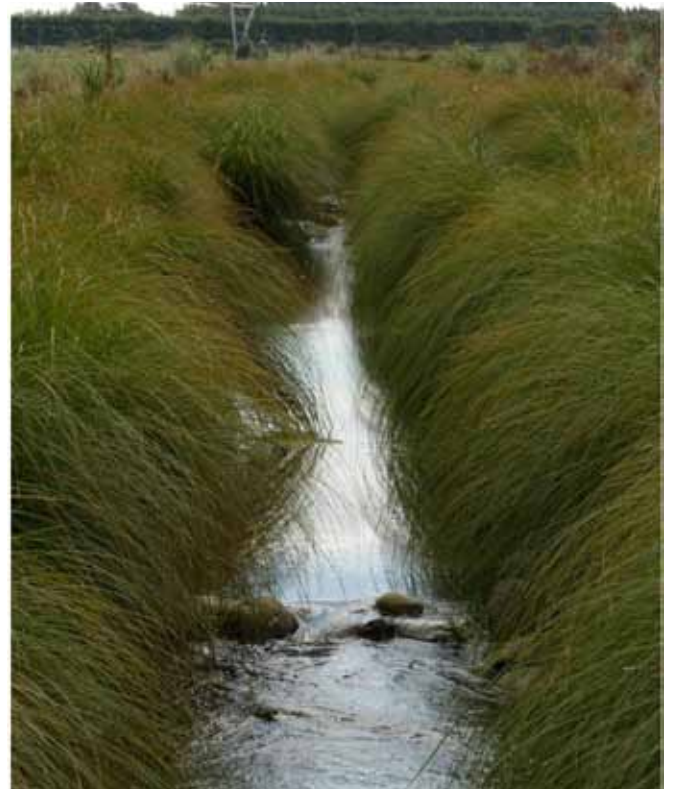
## Stream narrowing

Due to the stream being over-widened by mechanical excavation, trials were conducted to narrow the stream. This was carried out using hessian bags filled with cobbles. Some bags were filled with soil and *Carex secta* plants were planted into them.

As the plants rooted this helped to stabilise the bank and narrowed the stream effectively. The new bank has weathered changes in water level thus far.

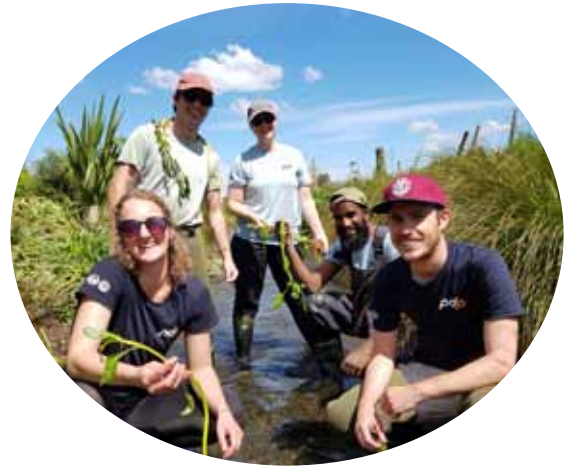
## Weed clearance during the restoration

Following completion of the restoration of a reach mechanical weed clearing ceased. Hand weeding was carried out until the shading of the banks was established. Pictured on the right are volunteers helping out.

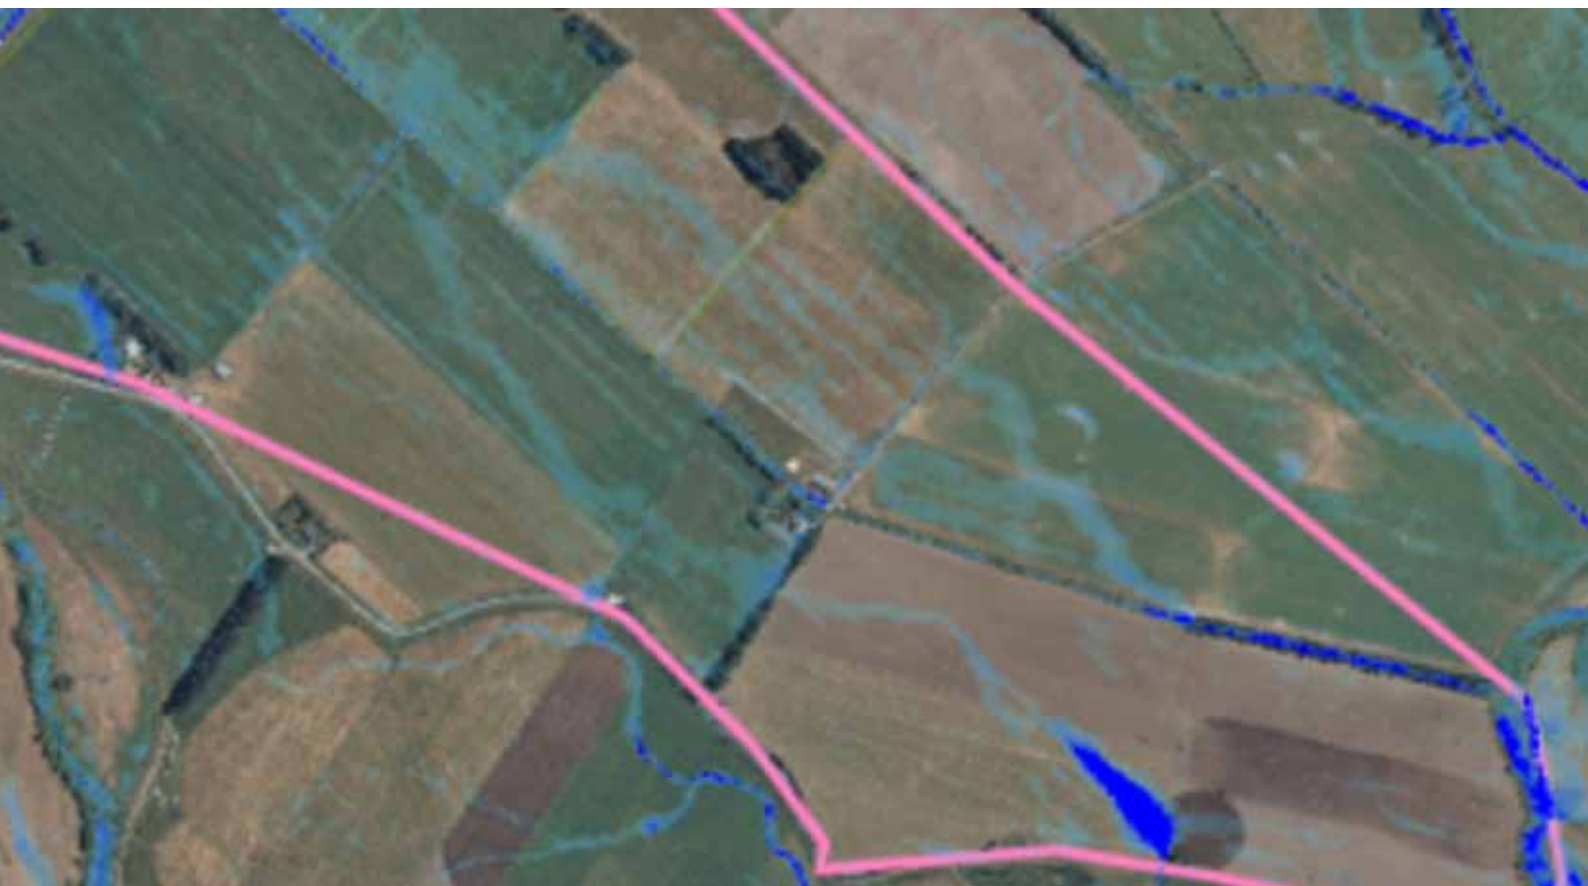
## Mapping run off

Due to concerns about the ongoing quantity of sediment being trapped in the traps it was decided to carry out overland flow path mapping to see where this sediment might be coming from. The mapping identified run off paths likely under certain rain events. The results could help guide future interventions, such as where to locate extra buffer areas or detention bunds and the size of such interventions. This technology could be a useful tool in fresh water farm planning.

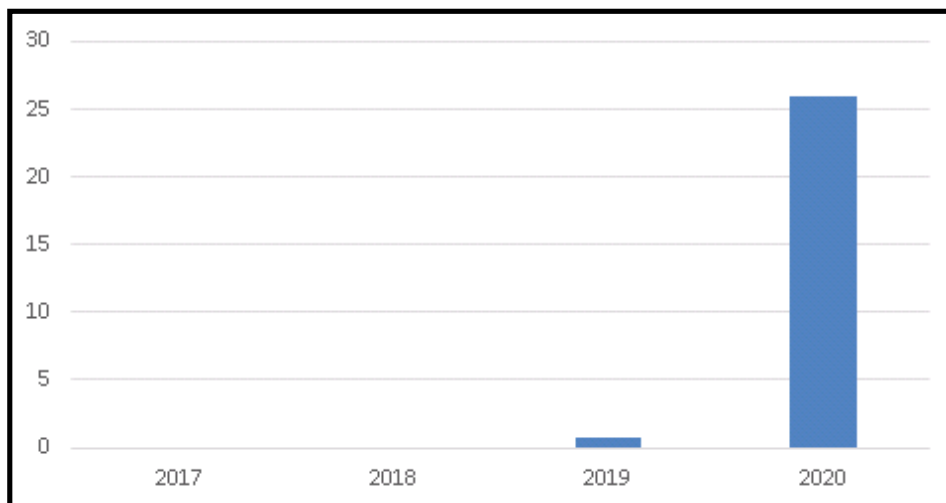
**Table 1: Percentage of leaf litter at the stage 1 monitoring site**

Leaf Litter is a valuable energy source. It provides food for invertebrates and Kekewai (freshwater crayfish) and increases nitrate absorption. Baseline monitoring showed no leaf litter in any of the four monitoring locations prior to restoration. This is likely due to annual mechanical weed clearance and a paucity of riparian vegetation. The study showed that leaf litter quickly builds up in the absence of mechanical clearance and the introduction of riparian sedges and shrubs. Some woody debris is starting to appear on the stream bed.

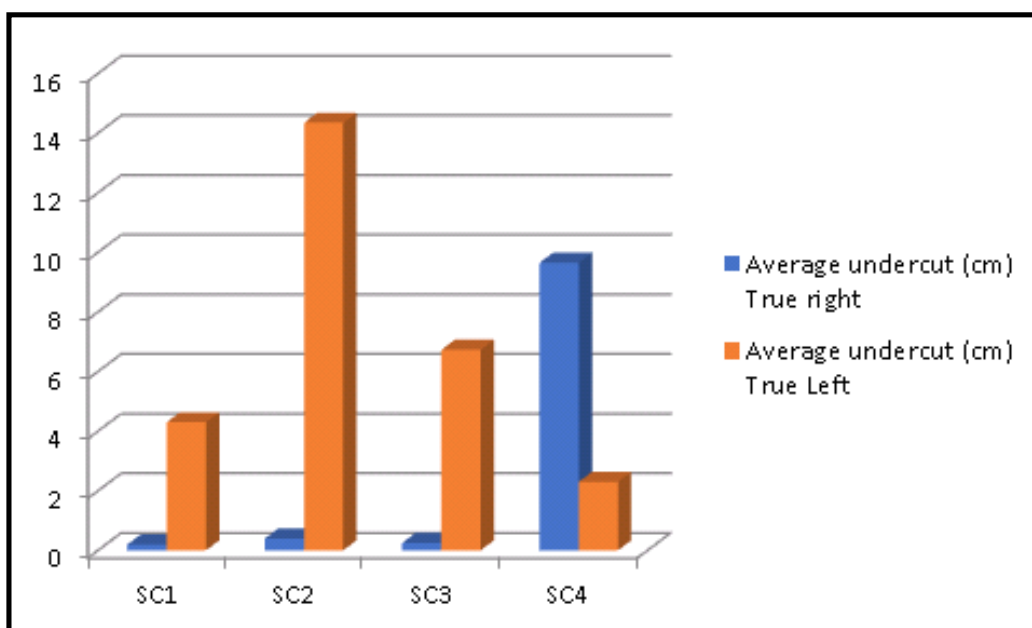
**Table 2: Degree of bank undercut at Snake Creek monitoring sites. SC1, SC2 & SC3 were historically cleared mechanically from the true right. SC4 was cleared from both sides.**

At Snake Creek the streams were cleared mechanically from one favoured bank. This is typically the bank that provides the easiest access. Our analysis shows that the side of the stream that excavation was historically conducted from has significantly less undercut habitat than the other side. This has potential implications for species that utilise this habitat, such as trout, long finned eel (tuna) and freshwater crayfish (kekewai). It is likely that, in time, undercut habitat will re-establish now that mechanical excavation has ceased.

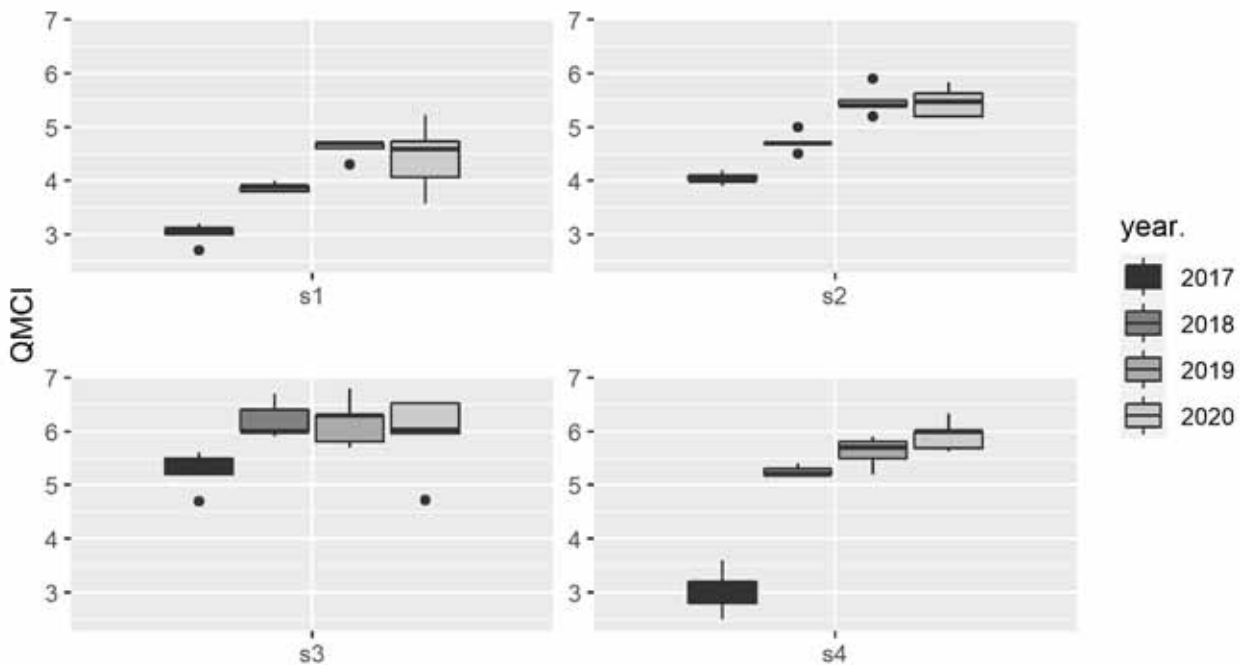
**Table 4: QMCI at sites 1-4 between 2017-2020 based on five replicate Surber Samples. Box plots show the median value, 25th & 75th percentile, 1.5 x the interquartile range and outliers**

Macroinvertebrates samples were taken from the streambed prior to any restoration work being carried out in 2017, then again in 2018,19 and 20. Refer to the graph below which shows improvements in the QMCI (Quantitative Macroinvertebrate Community Index).

A higher score QMCI score represents the presence of more sensitive macroinvertebrates and thus better habitat. Unfortunately, due to a drought that occurred in 2017 it is not possible to attribute the improvements solely to the restoration works, as this same shift in QMCI was seen in neighbouring streams with the return of flow. Further monitoring would be required to confirm the correlation.
